# Electric Locomotives in Two Wrecks

**Man Failure and Act of Providence Are Causes of Two Accidents on C., M. & St. P. Mountain Division—Electrical Equipment in No Way at Fault**

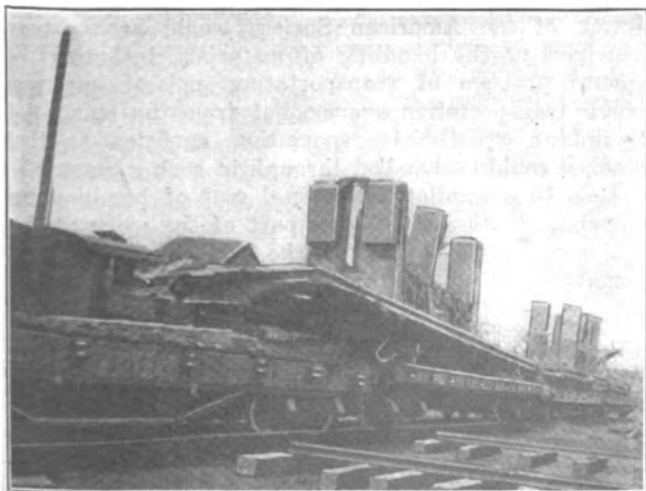
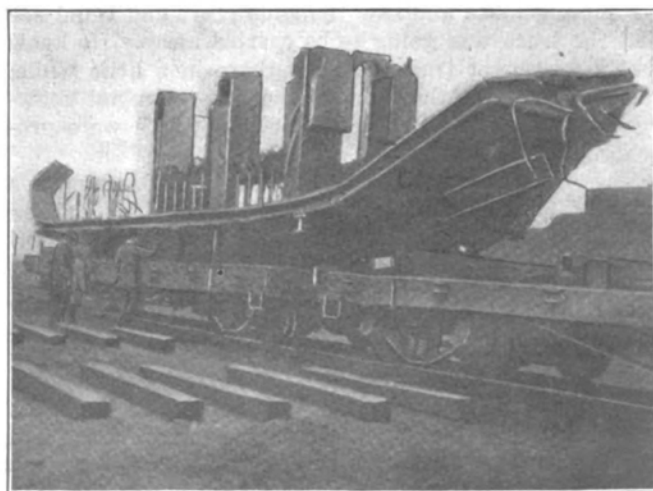
**PARTS OF WRECKED MILWAUKEE LOCOMOTIVES AS RETURNED TO THE WEST TACOMA SHOPS**  
These underframes are being straightened and the rehabilitated locomotives will soon be in regular service.

These locomotives, Nos. 10,208 and 10,240, rounded a curve at 15 or 16 miles per hour and entered the sunken track, rolling and sliding down the slope to a point about 400 ft. below. The two engineers and two firemen carried down with them were practically uninjured. An instructor and brakeman had to be taken to a hospital, but they recovered. The cabs of both locomotives were almost completely wrecked. The underframes were badly bent and twisted and the sheeting on the sides and roof was stove in by hitting against rocks and trees as the engines slid down the embankment so that it was practically beyond reclamation. Inside the cabs the motor-generator sets, rheostats, control equipment, air compressors, wiring, etc., were practically all torn

from their fastenings and damaged more or less. The engine trucks, short and long main trucks, driving wheels and motors of both locomotives were very little damaged. The brake rigging on one engine was little damaged, while that on the other was damaged to some extent.
