INTERSTATE COMMERCE COMMISSION

-----  
ACCIDENT ON THE  
CHICAGO, MILWAUKEE, ST. PAUL AND PACIFIC RAILROAD

-----  
AVERY, IDAHO

-----  
INVESTIGATION NO. 2379

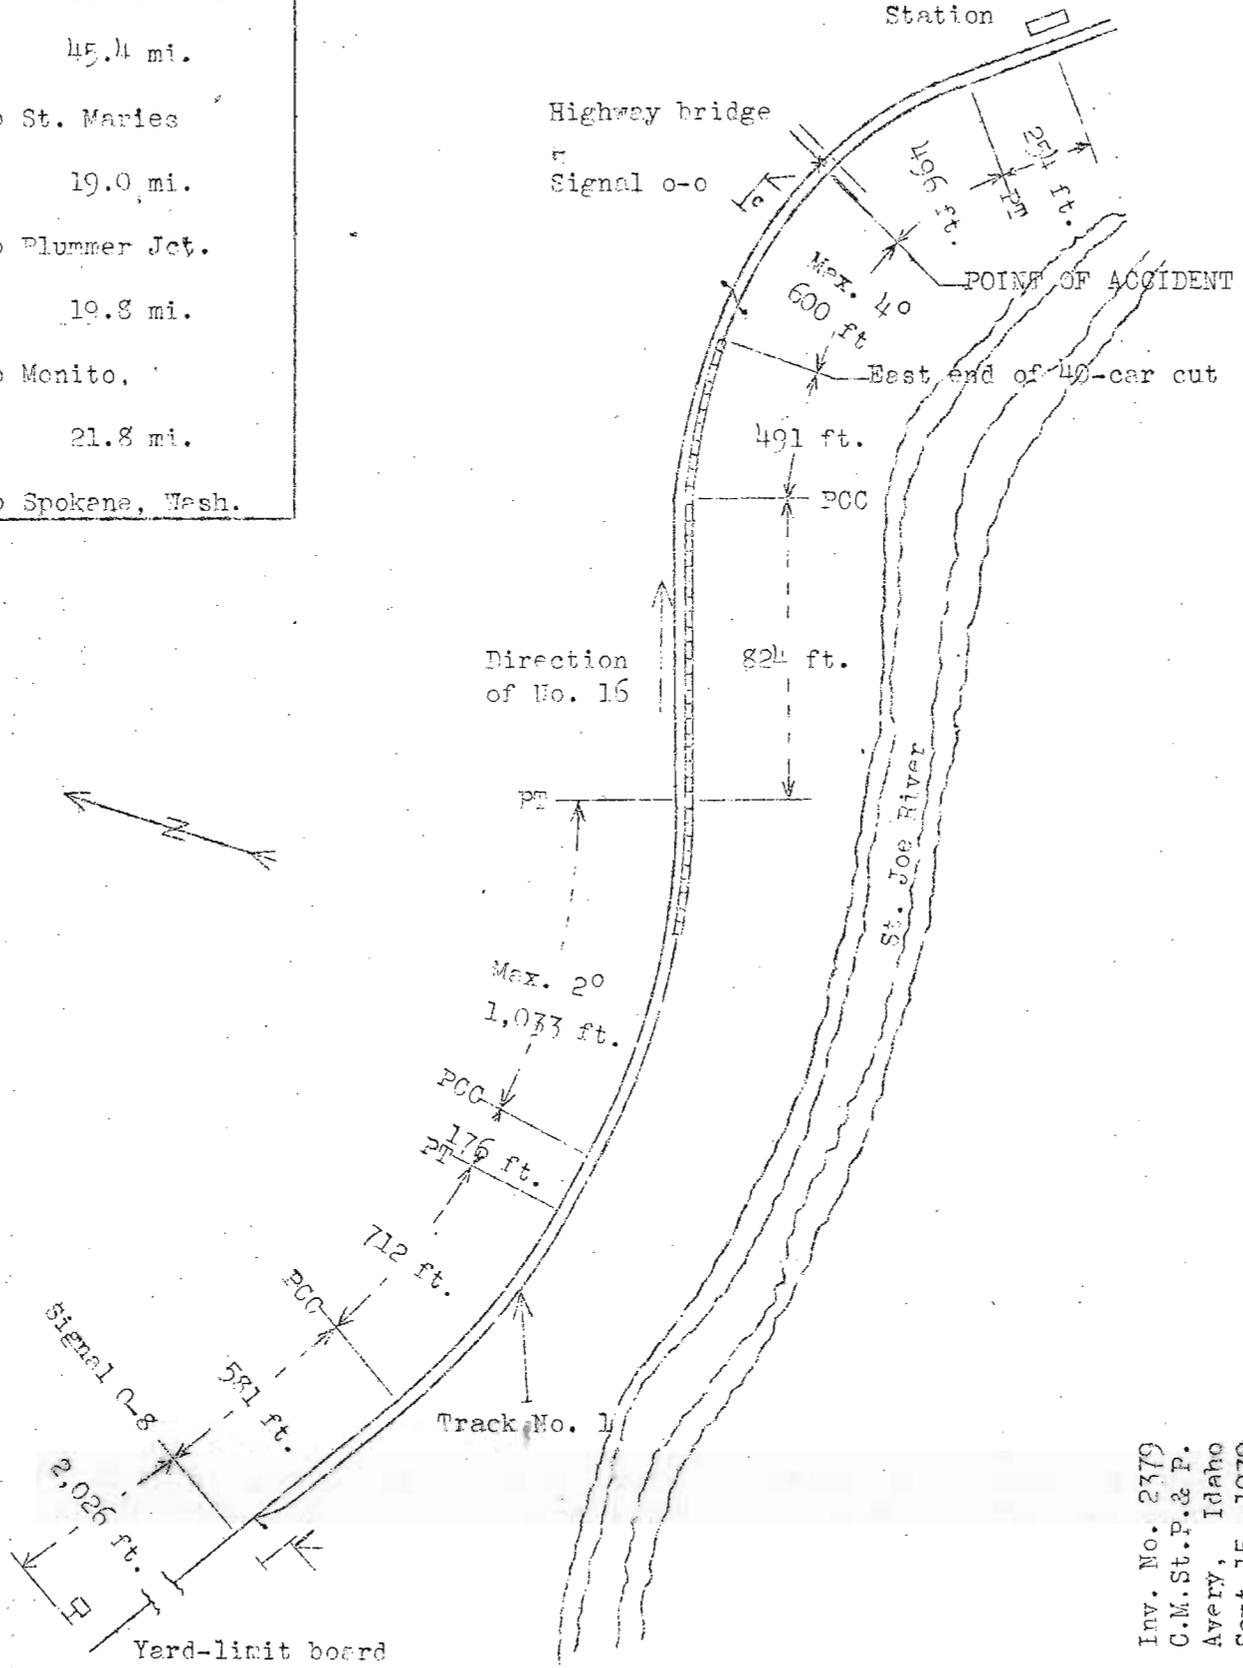
Inv. No. 2379  
 C.M.St.P.& P.  
 Avery, Idaho  
 Sept 15, 1979

o	Avery, Idaho
x	Point of accident
	45.4 mi.
o	St. Maries
	19.0 mi.
o	Plummer Jct.
	19.8 mi.
o	Monito.
	21.8 mi.
o	Spokane, Wash.

Automatic signals O-8 and O-0 governing eastward movements are located 4,417 and 169 feet, respectively, west of the point of accident. Signal O-8 is located on the south side and signal O-0 is located on the north side of the main track. Signal O-8 is a 3-position, upper quadrant, semaphore signal, continuously lighted, and is controlled by a D. C. polarized relay; its indications are:
