INVESTIGATION NO. 2972

CHICAGO, MILWAUKEE, ST. PAUL AND PACIFIC  
RAILROAD COMPANY

REPORT IN RE ACCIDENT

NEAR NEW LISBON, WIS., ON

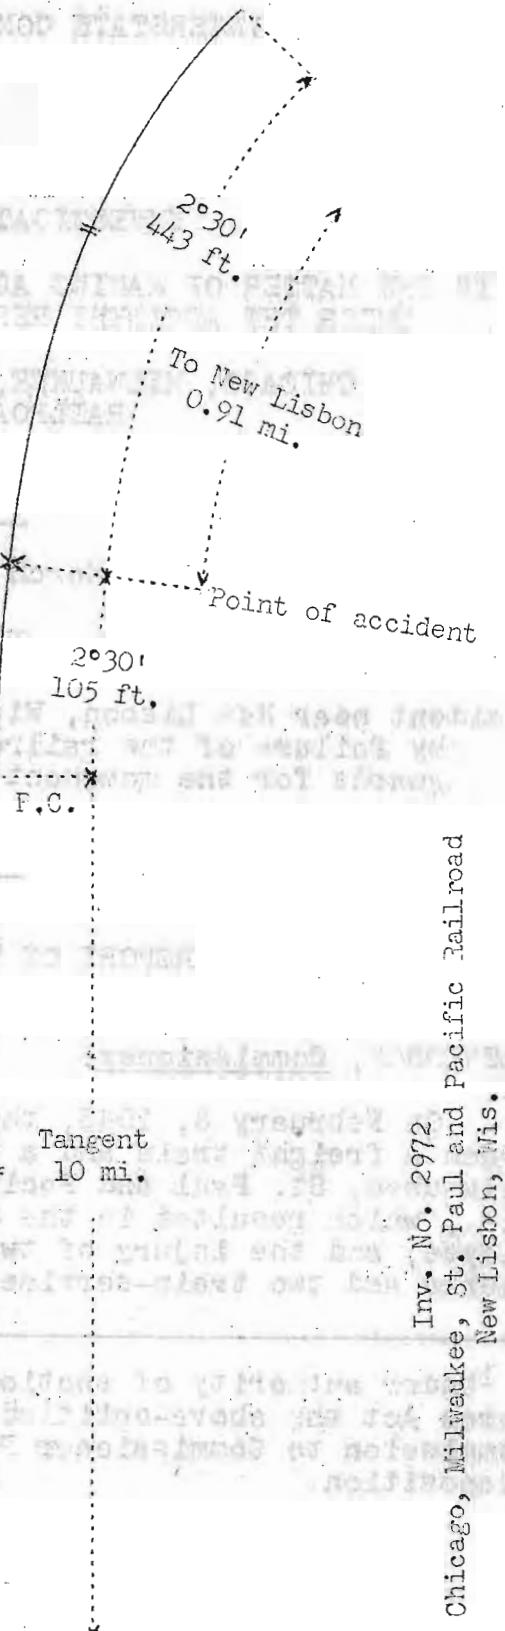
Inv. No. 2972  
Chicago, Milwaukee, St. Paul and Pacific Railroad  
New Lisbon, Wis.  
February 5, 1946

← To Wausau

Direction of trains →

Location of Accident and Method of Operation
